## MSP430G2553 Device Erratasheet

### 1 Functional Errata Revision History

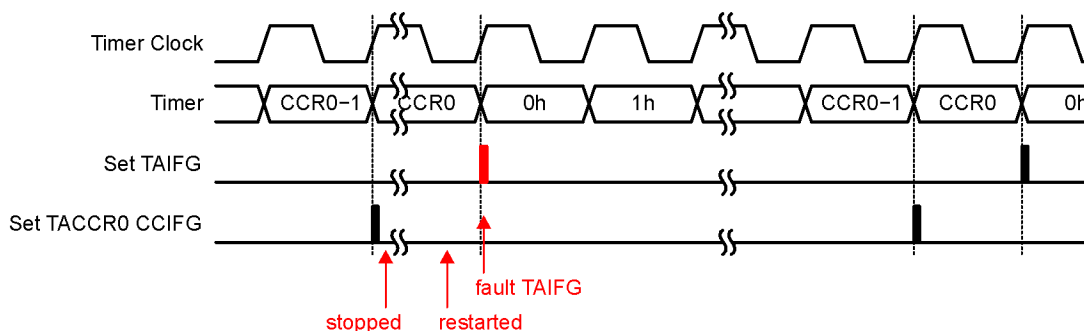
**Function** TAIFG Flag is erroneously set after Timer A restarts in Up Mode

**Description** In Up Mode, the TAIFG flag should only be set when the timer counts from TACCR0 to zero. However, if the Timer A is stopped at TAR = TACCR0, then cleared (TAR=0) by setting the TACLr bit, and finally restarted in Up Mode, the next rising edge of the TACLK will erroneously set the TAIFG flag.

**Workaround** None.
