Intel[®] Atom[™] Processor E6xx Series

Specification Update

July 2014

Revision 017

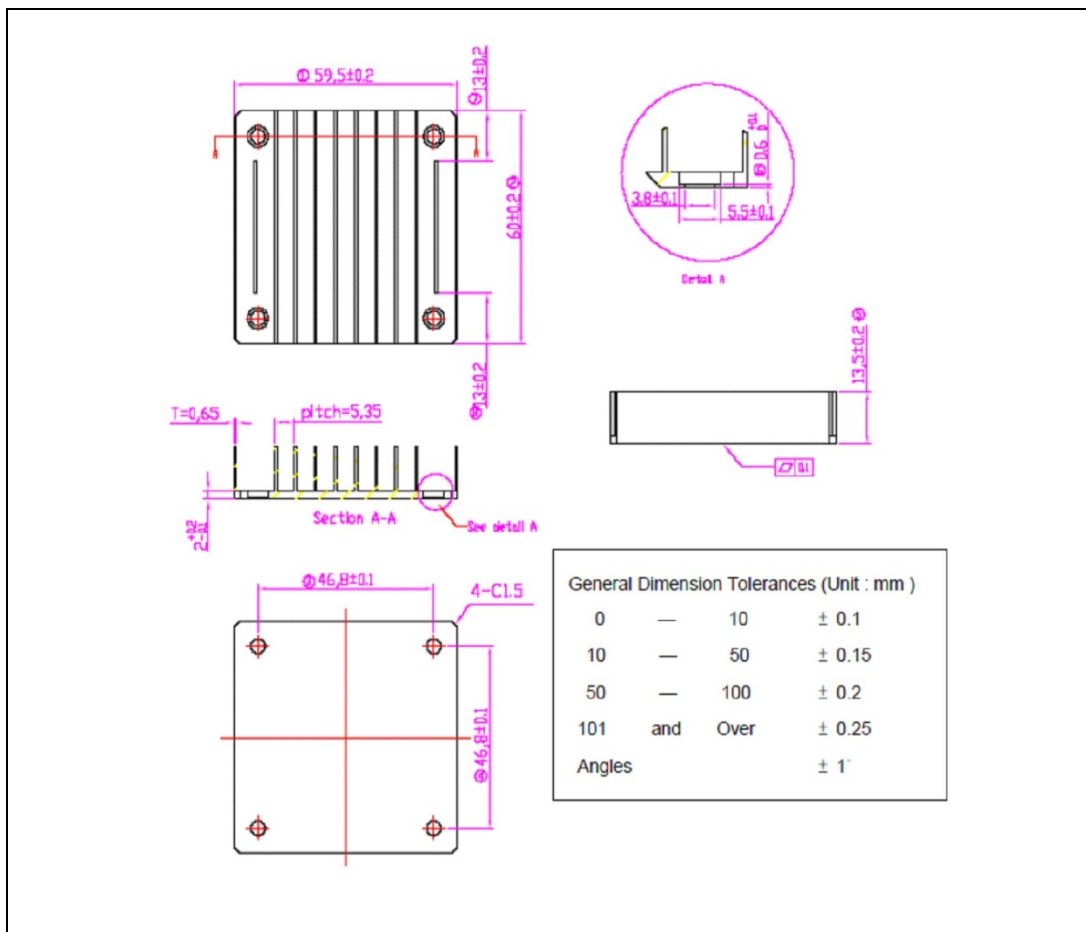
Figure 10. 1U Natural Convection Heatsink Mechanical Drawing

Issue: Heatsink height on Figure 10 “1U Natural Convection Heatsink Mechanical Drawing” has changed from 13.5 ± 0.2 mm to 29 ± 0.2 mm.

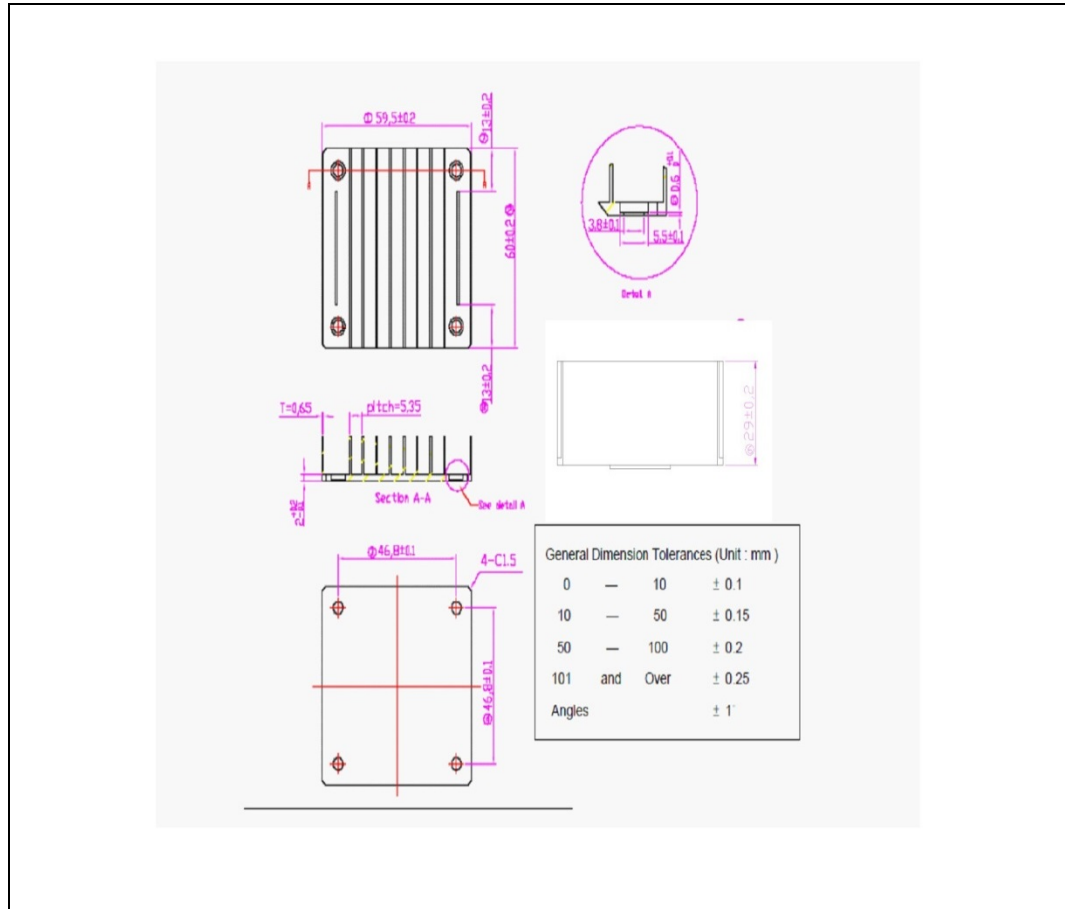
Figure 10. 1U Natural Convection Heatsink Mechanical Drawing

Affected Docs: Figure 10 “1U Natural Convection Heatsink Mechanical Drawing” of *Intel® Atom™ Processor E6xx Series Thermal and Mechanical Design Guidelines, Rev 003*.
